Manhole Inspection Summary

Manhole # S57O__001MH

Insp Date: **1/13/09 9:36 AM**

Location Address: **3701 odonnell st**

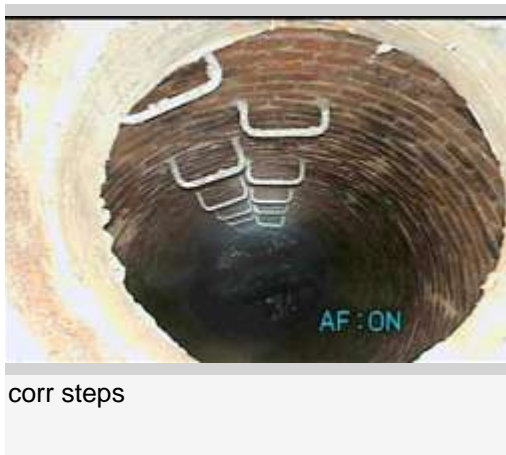
Defect 1

Count: **17** Missing: **0** ☒ **Corroded**

corr steps

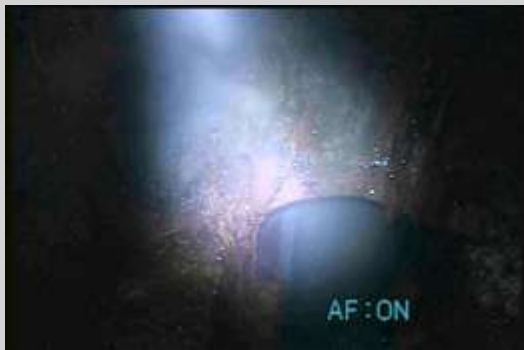
12 O'Clock Outflow

to far down for better pic
